### FINAL REMEDIAL ACTION REPORT

OMC Plant 2 Site (OU4)

In Situ Soil Mixing Remedy

Waukegan, Illinois

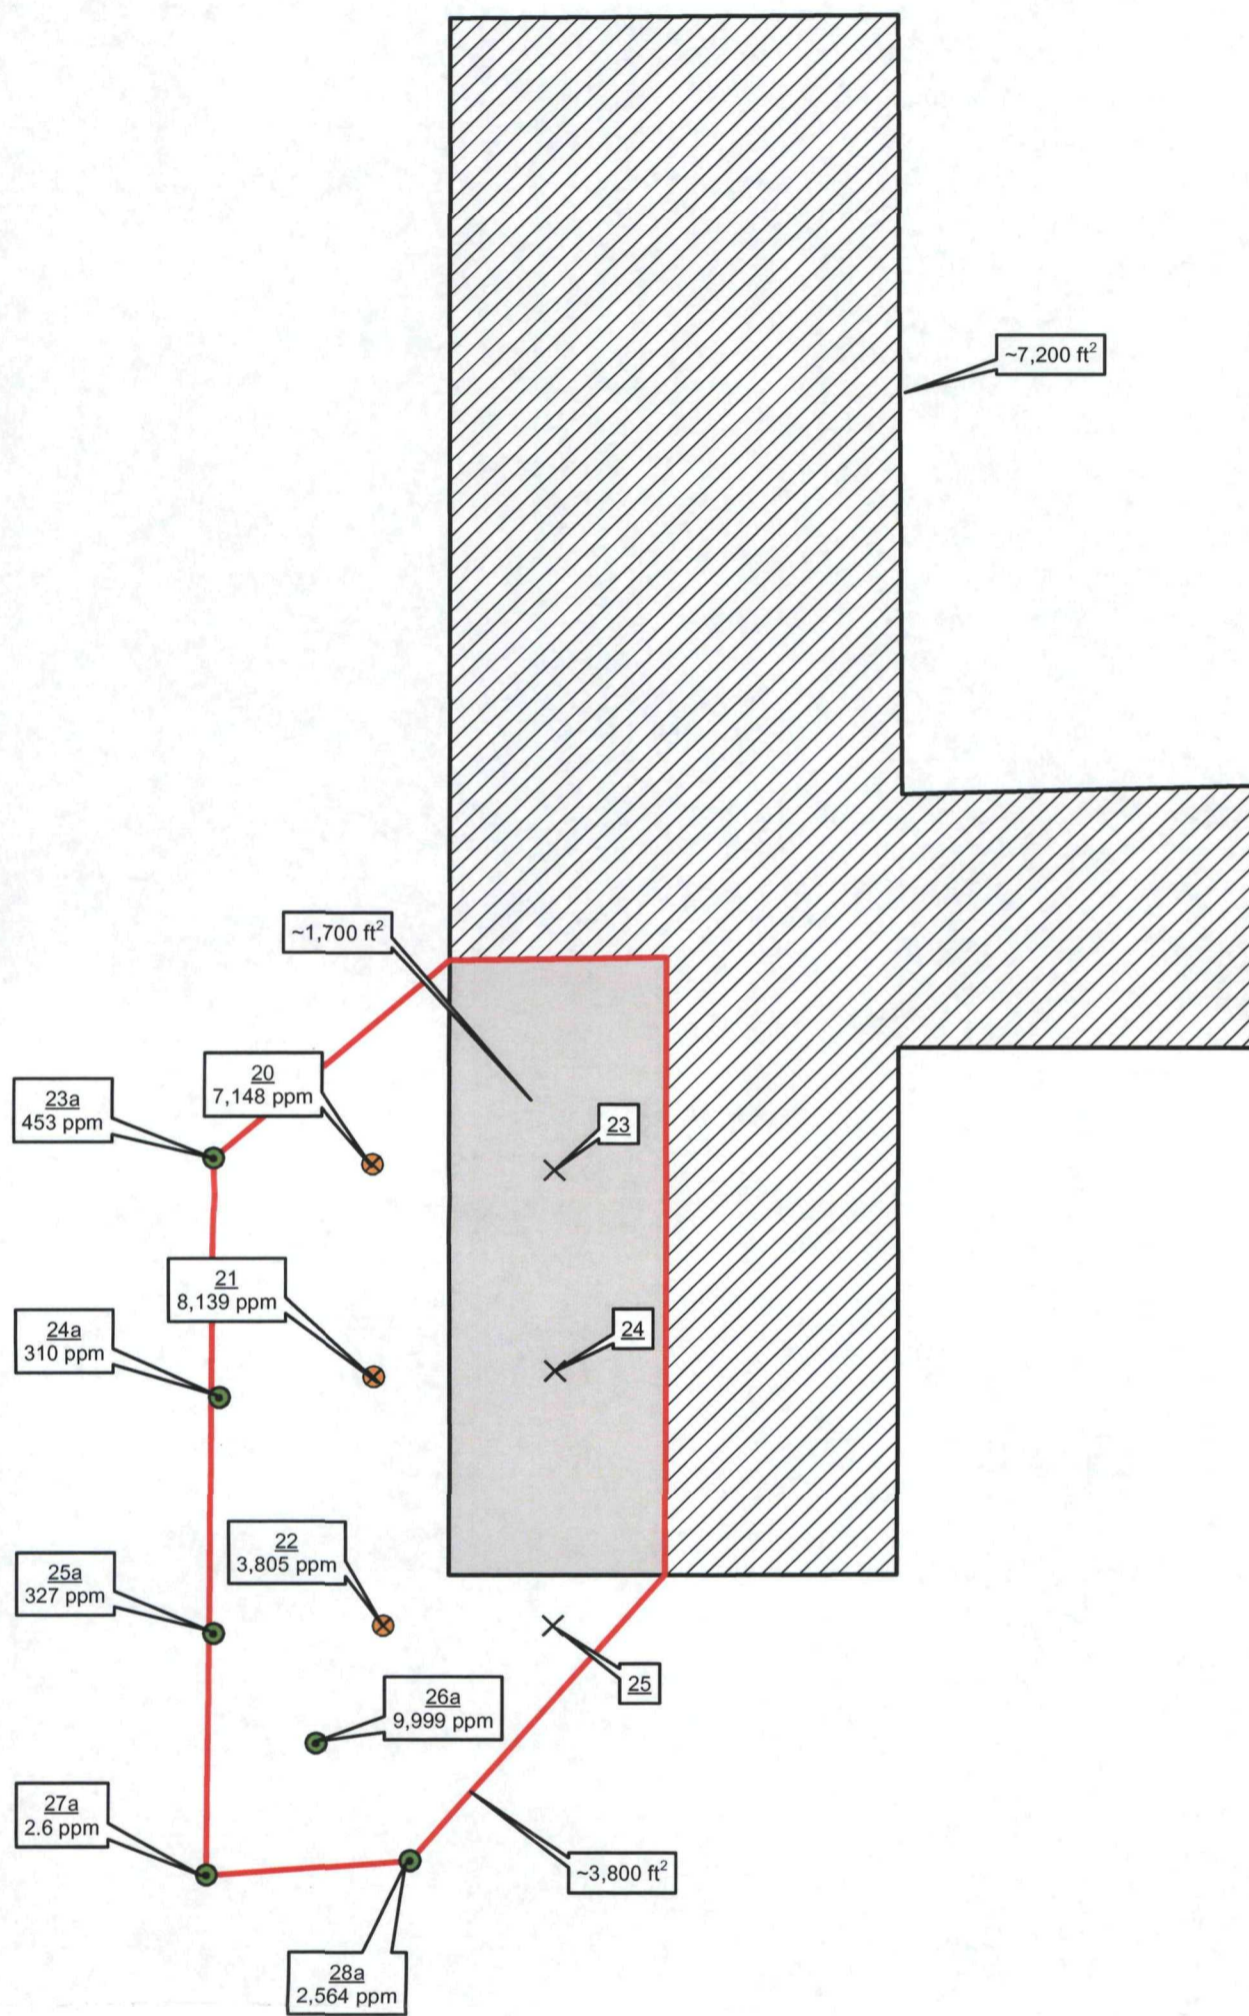
#### Legend

- Stepout Delineation Boring
- ⊗ Planned Delineation Boring(Completed)
- ✕ Planned Delineation Boring(Not Completed)
- ▨ Delineated TCE DNAPL
- Estimated Southwest Extent of TCE DNAPL
- September 2011 Delineated Southwest Extent of TCE DNAPL

Based on the delineation results, the DNAPL treatment area was found to be larger than the 9,900 ft<sup>2</sup> estimated in the design. The new ISSM treatment area was expanded to encompass about 11,020 ft<sup>2</sup>, resulting in an estimated treatment volume of 11,425 cubic yards.

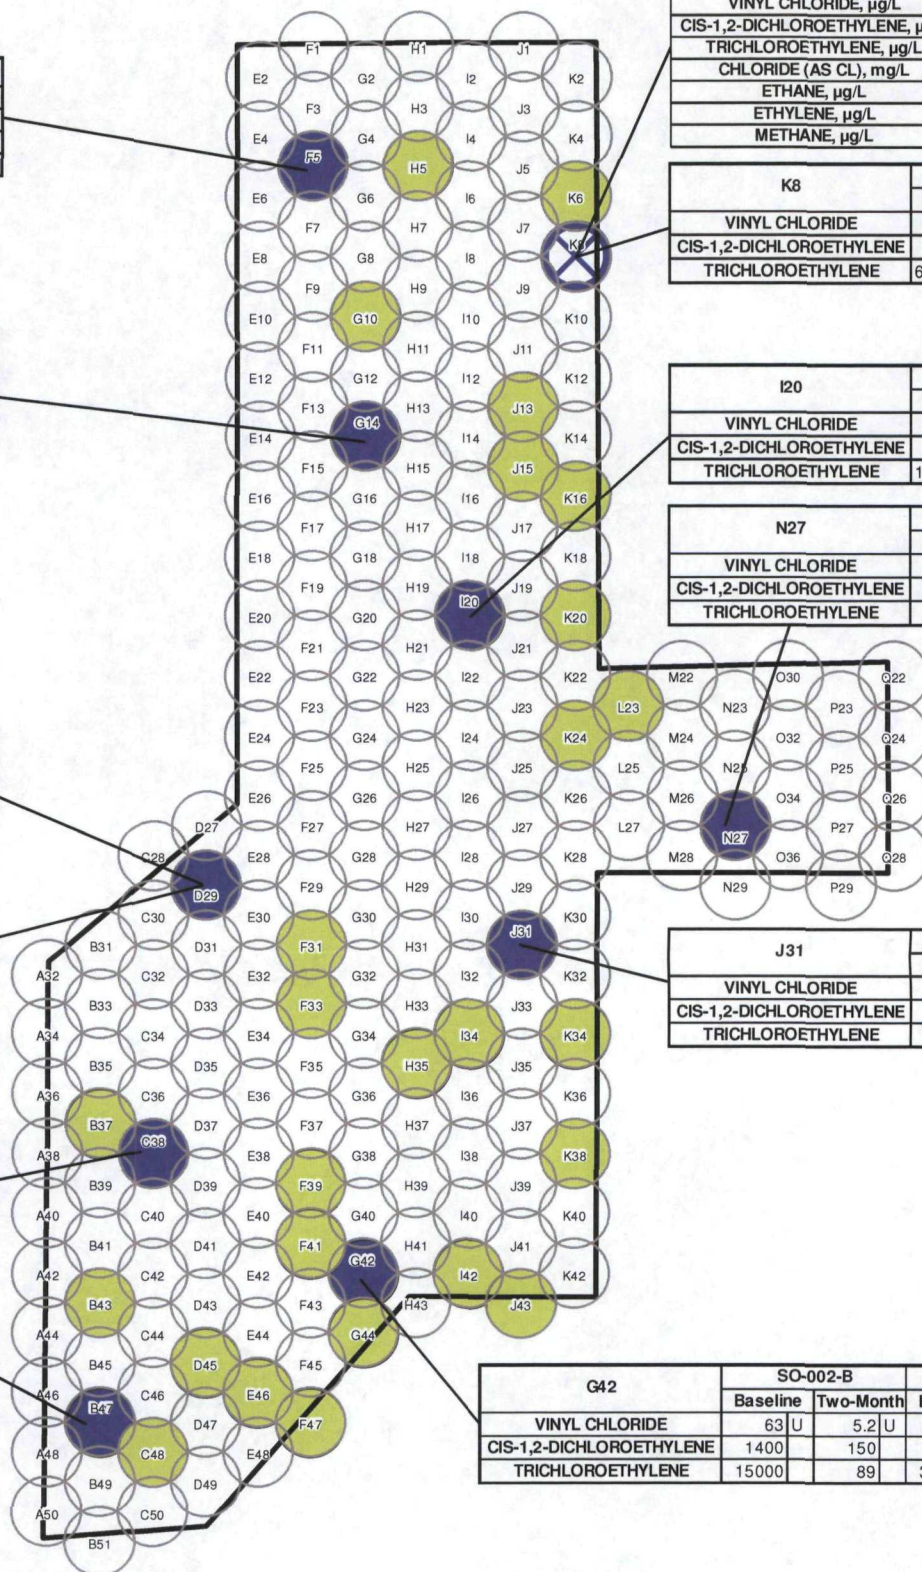
Figure 3-2  
Iron Content and VOC Sampling Results  
OMC Plant 2 ISSM  
Waukegan, IL

- Sample Collected For Iron Content Analysis
- Sample Collected For Iron Content and VOC Analysis
- ⊗ Sample Collected for VOC Analysis Only

Notes:  
All samples analyzed for iron content met or exceeded the target percentage of 2% +/- 0.5%.  
All results in micrograms per kilogram, unless otherwise noted.  
Temporary monitoring wells installed at locations K08 and D29.

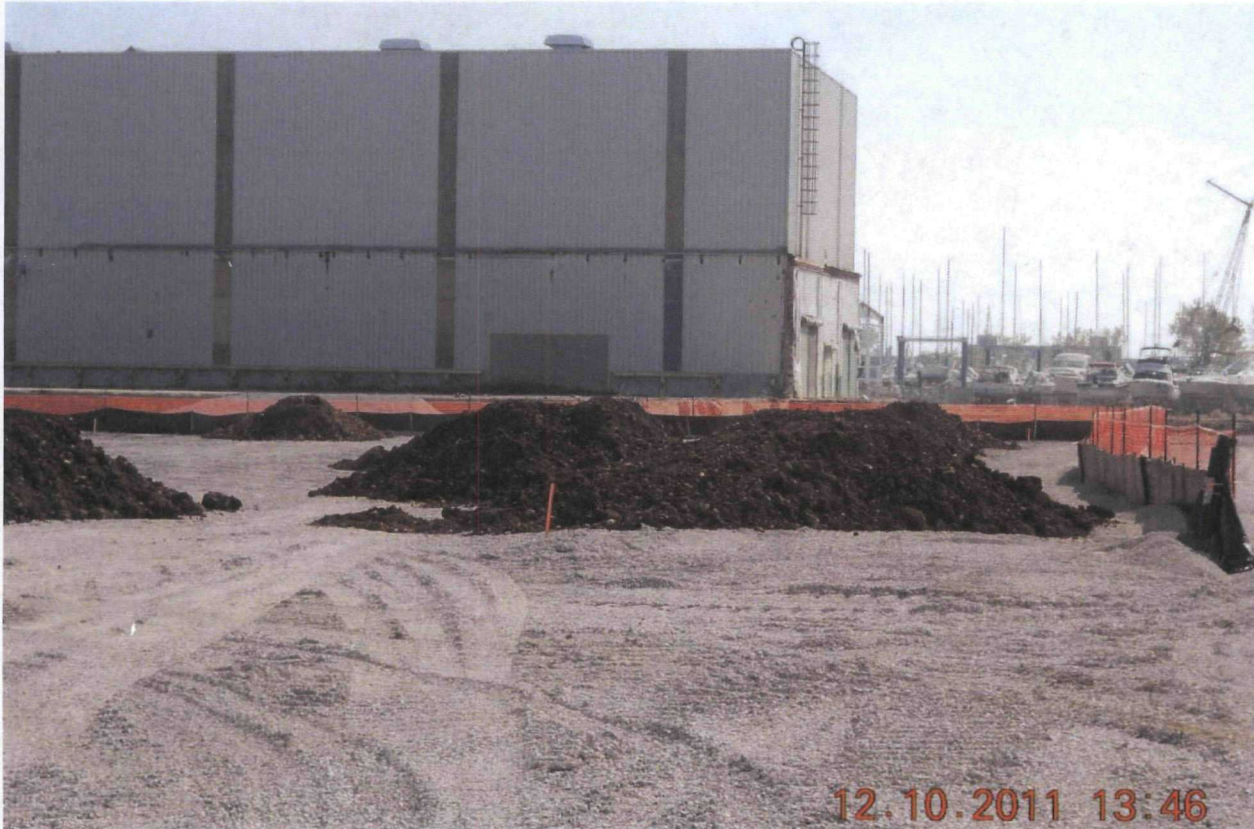
6. Containment Berm, Silt, and Snow Fence

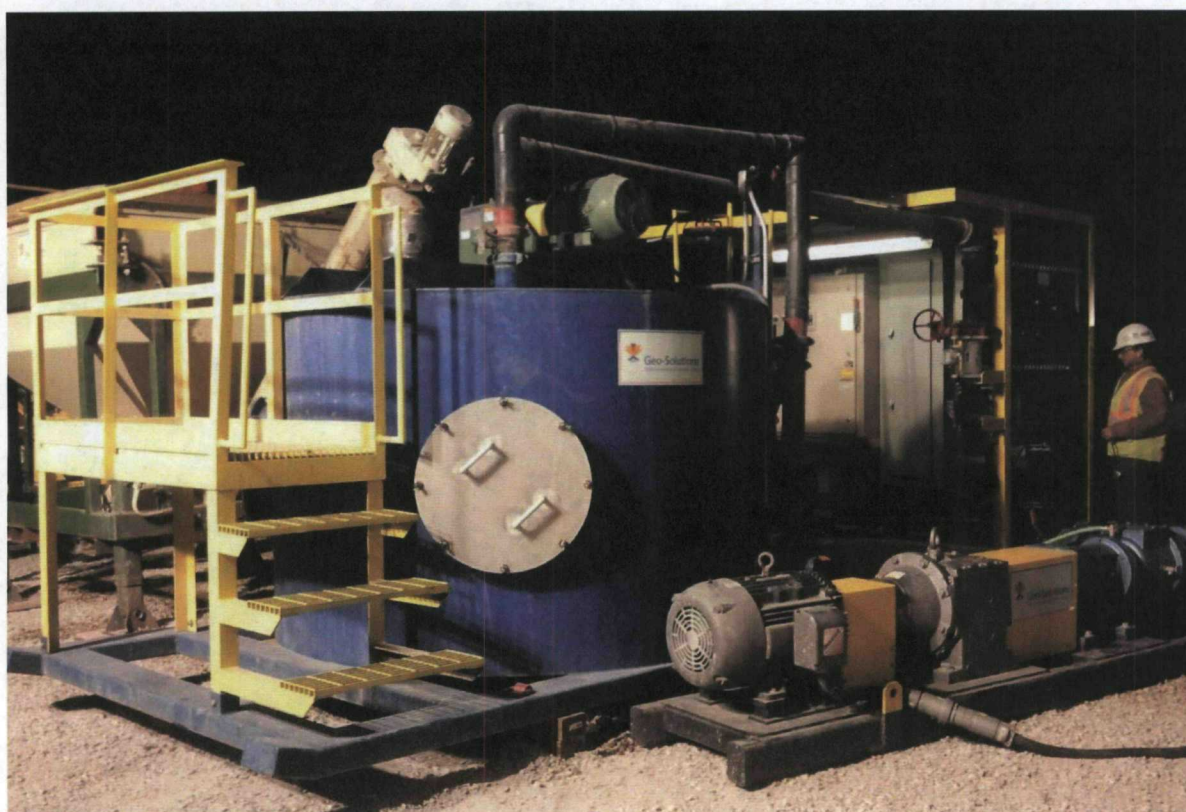
22. New Batch Plant and Pump

The original batch plant was replaced on November 19, 2011. The configuration was altered because of plugging caused by the addition of dry ZVI at the fluid intake stream immediately prior to the progressive cavity pump, reducing the suction capabilities of the pump until it was no longer functional. The new batch plant configuration used the same flash mixer to produce bentonite slurry but included a second mixer. Bentonite slurry was pumped into the second “lightning mixer” where ZVI was added through the supersack silo with load cells. High-speed mixing paddles kept the ZVI in suspension until the bentonite/ZVI slurry was pumped through the progressive cavity pump to be delivered to the ISSM column. A separate connection and valves were added prior to the pump to accommodate pumping a bentonite-only slurry through to the column when necessary.

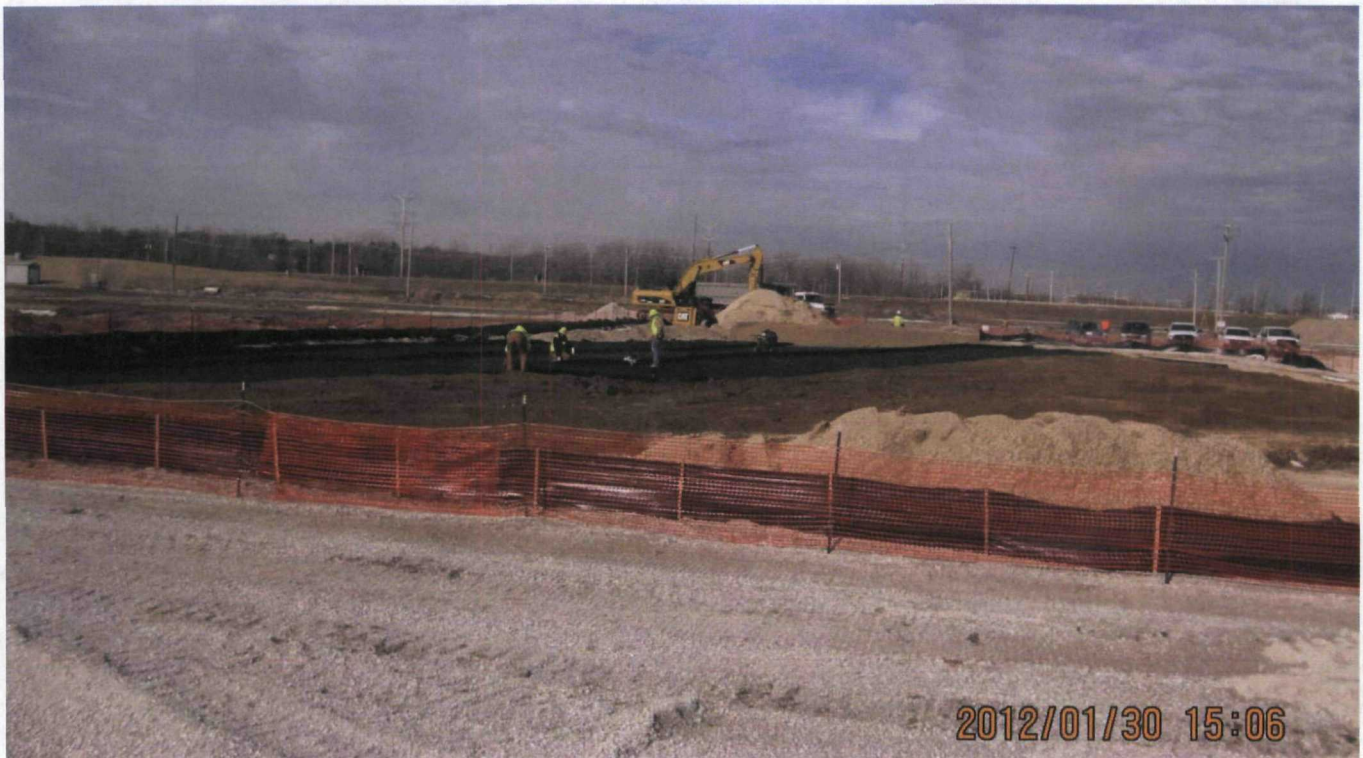
41. Geotextile Placement and Sewing

Final topsoil, seeding, and fence installation was determined unnecessary due to current conditions of the site and the additional construction activities that will be occurring as part of the Waukegan Harbor RA. A final site survey of the graded and backfilled soil mixing area, with geotextile fabric, was conducted on April 30, 2012, by Howard

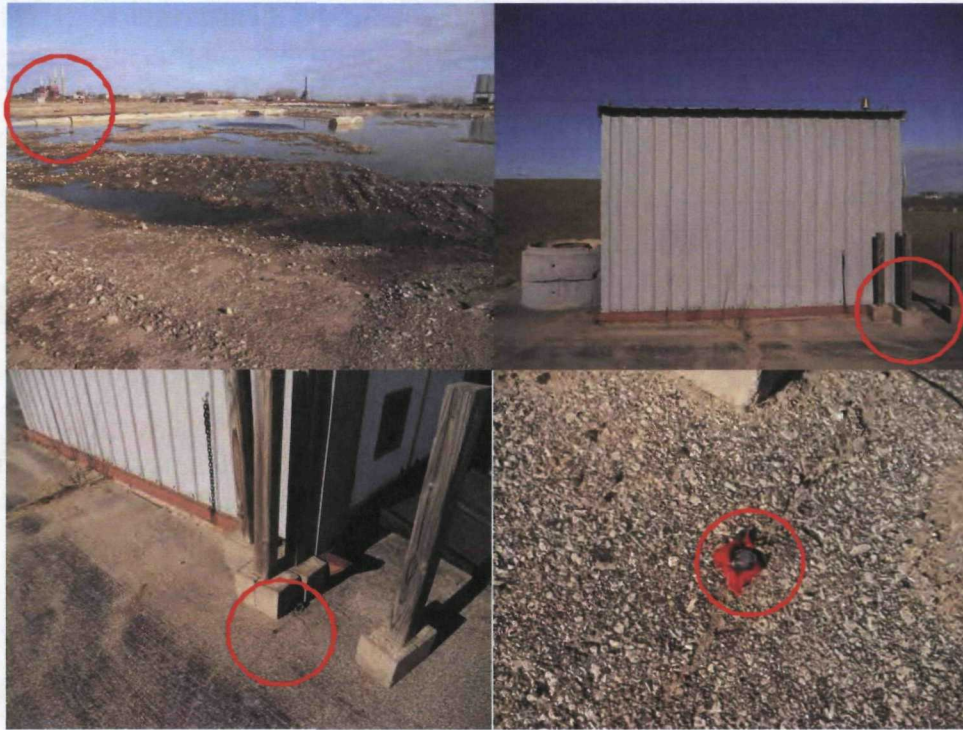
GSI CP 1 is a bolt located on the asphalt near the southeastern corner of the existing site treatment building (below).

Northing: 2078271.26  
Easting: 1122444.66  
Elevation (MSL): 585.12

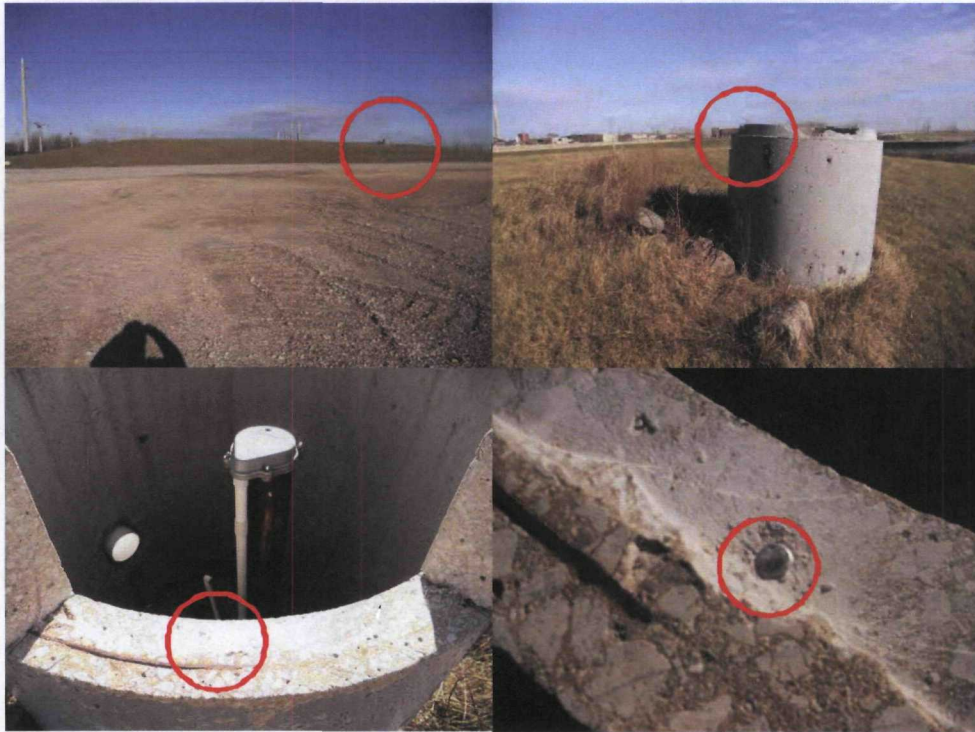
GSI CP 2 is a bolt located on the cement well protector on the eastern side of the western PCB containment mound (below).

Northing: 2078362.94  
Easting: 1122346.59  
Elevation (MSL): 601.27

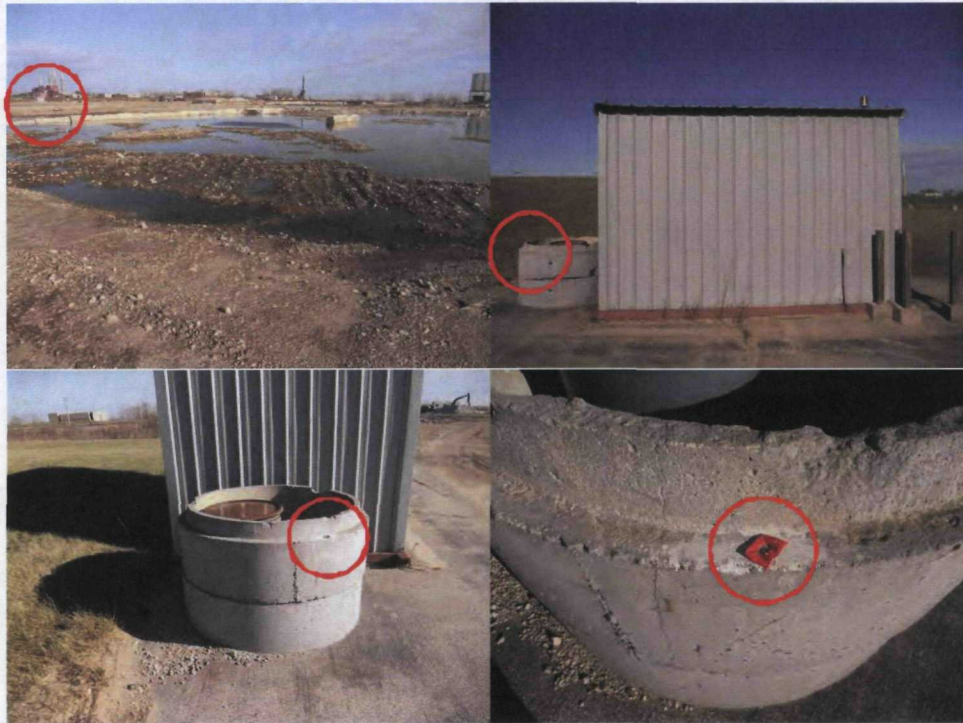
GSI CP 3 is a bolt located on the cement well protector sitting near the existing site treatment building (below).

Northing: 2078275.57  
Easting: 1122425.15  
Elevation (MSL): 588.08
